TURBINE ENGINE FUEL CONTROL RELIABILITY
TEST AND EVALUATION

Colt Industries, Incorporated

Army Air Mobility Research and Development
Laboratory

July 1974

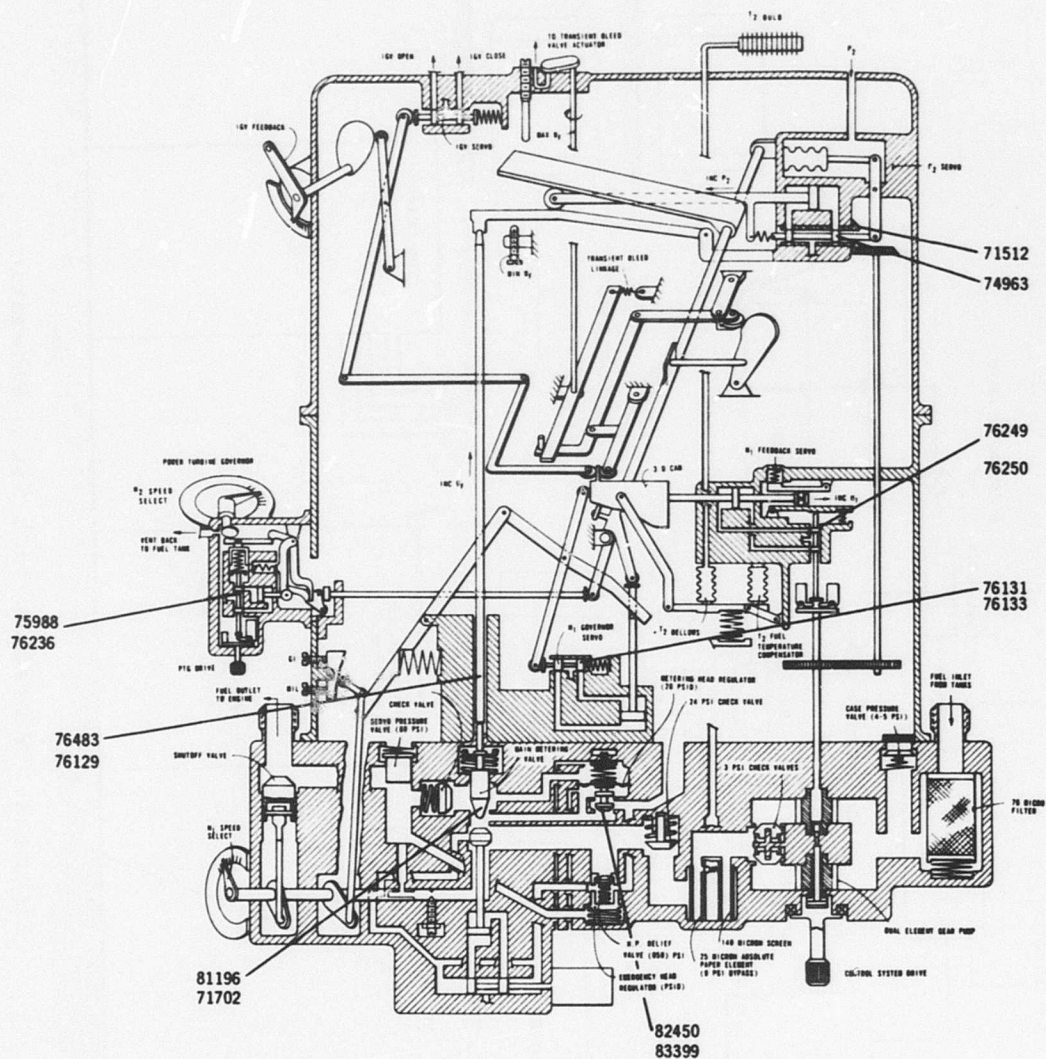
Figure 1. TA-2S Schematic.

NUMBERS SHOWN REFER TO PART NUMBERS LISTED IN TABLES IV AND V

Two overhauled Chandler Evans Model TA-2S fuel systems (S/N 692AS8403 and 692AS7472) of the type used on the Lycoming T53-L-13 gas turbine engine were subjected to sinusoidal vibration during normal operating conditions. The control is a unitized, hydromechanical design consisting of an integral dual element gear pump, gas producer control and power turbine governor, as shown schematically in Figure 1. Metered fuel flow was continuously monitored during vibration tests in an effort to detect flow variations which could induce engine performance disturbances and thereby result in the rejection of a bench-tested and previously acceptable unit. In over 10 hours of testing on the two fuel systems, some fuel flow shifts and oscillations were observed. However, the magnitude of flow variation was within the operating flow limits of the control. Furthermore, the largest steady metered flow shifts would yield only a ± 1.5 -percent N_2 and a ± 0.3 -percent N_1 variation when operating closed loop on the power turbine and gas producer governors, respectively. These engine disturbances are relatively minor, and in all probability would not be cause for removing the fuel control.

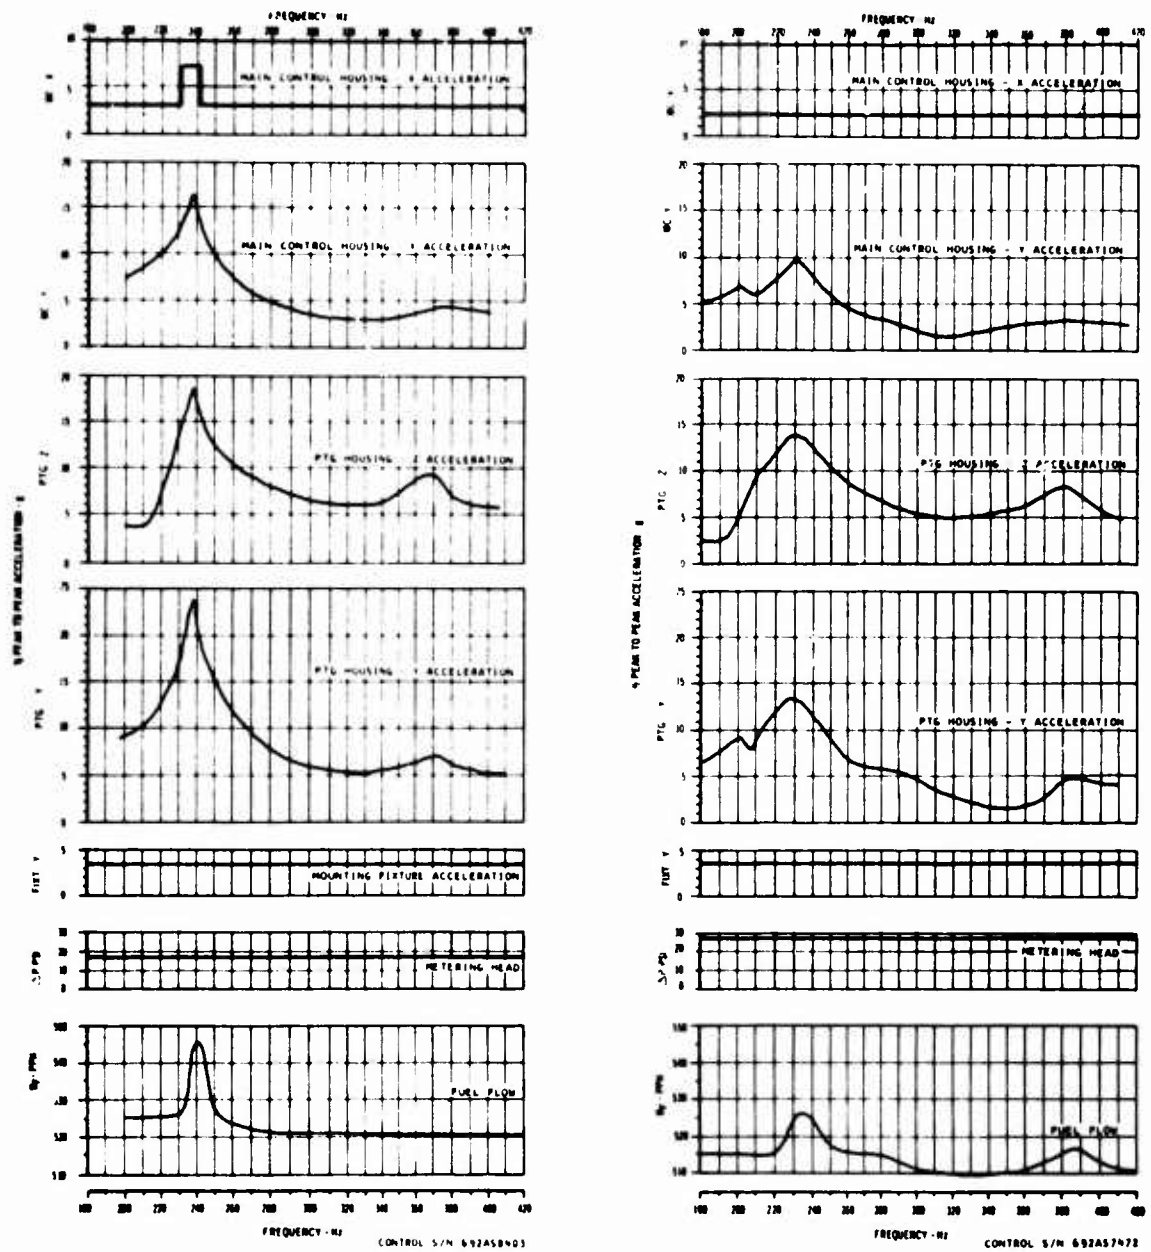
Figure 8. Power Turbine Governor Performance During Vibration in X Plane.

At 400 Hz, although the structural transmissibility is significantly lower, the high level of input excitation resulted in accelerations of the PTG housing of approximately 50 g's. A plot of governor performance of both control systems at a constant, low level of excitation is given in Figure 8. This figure shows operation at the two major structural resonant points and reveals their relative magnitudes and effect on metered flow.

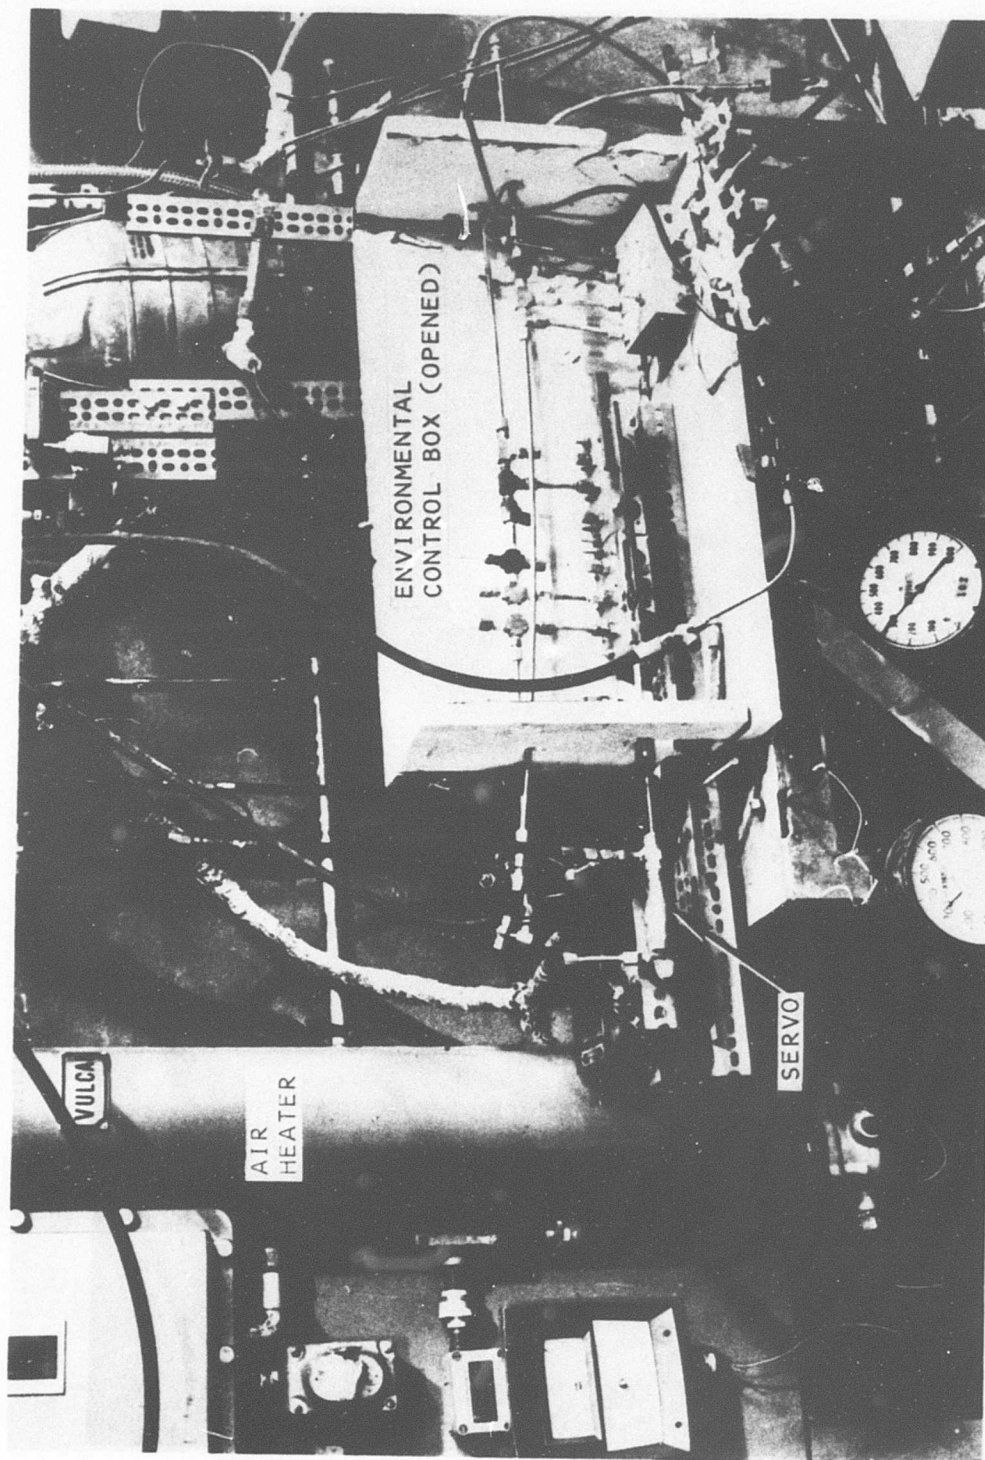
Figure 19. Seal Test Setup for 250°F Test.

Hot temperature testing was achieved by blowing hot air into the environmental box, thereby heating the test fixtures as well as the fuel in contact with the seals. Fuel flow was calculated to be approximately 10 gal./hr. in the translational test fixture. No fuel flow was required for the rotational fixtures. Because of the low fuel flow rate, it was not necessary to heat the fuel with a heat exchanger. Fuel and ambient temperatures were maintained at 250°F. Figure 19 shows the 250°F test setup.

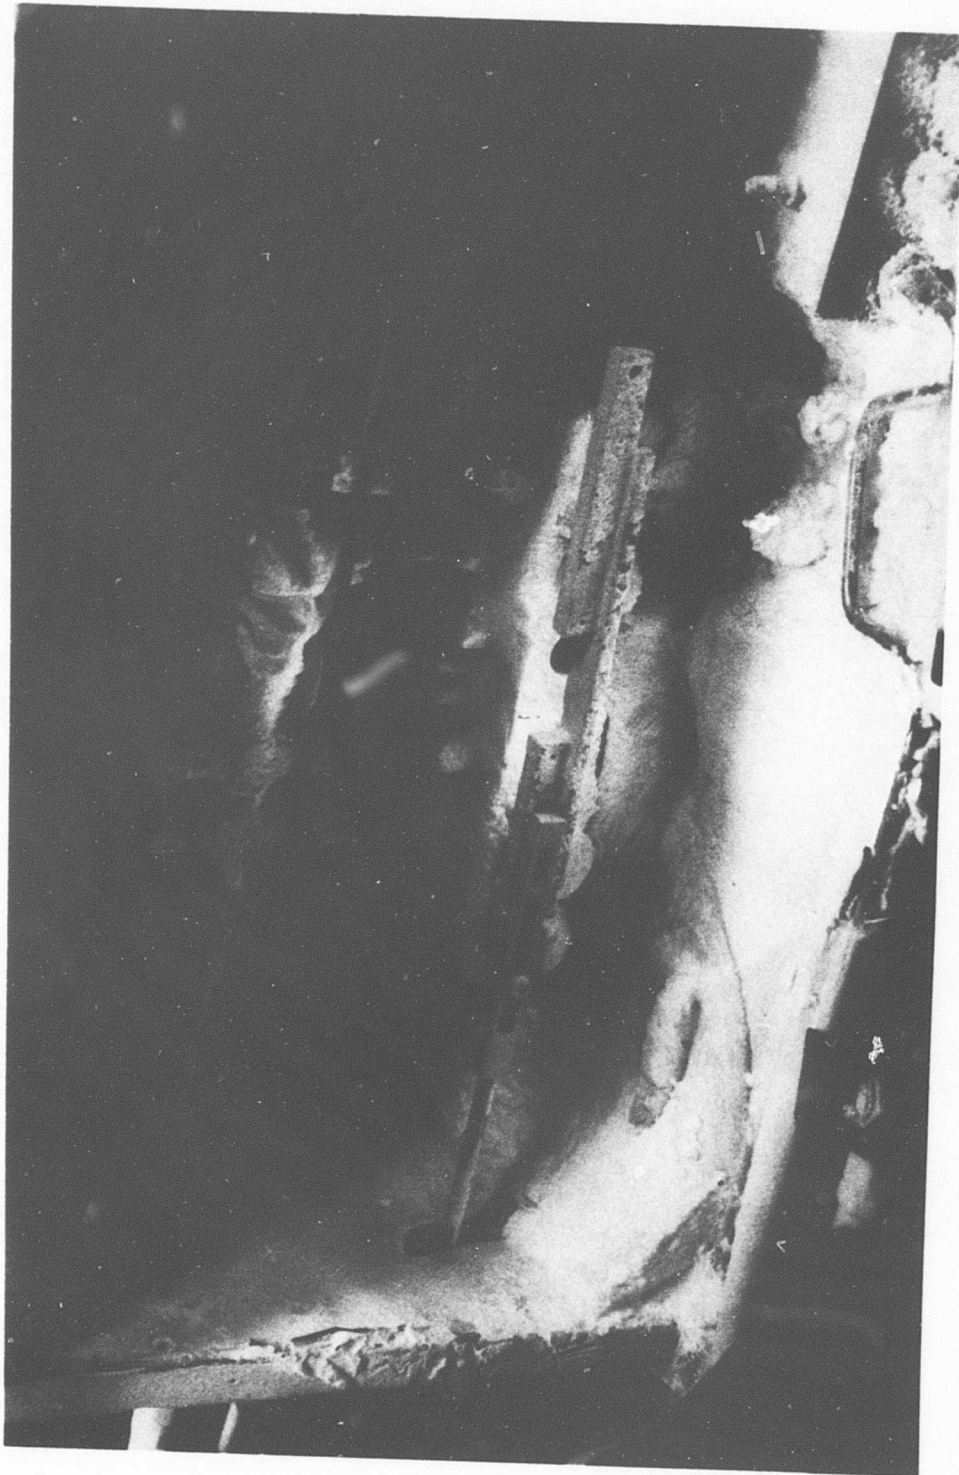
Figure 20. Seal Test Environmental Box at -65°F .

Cold temperature testing was achieved by cooling the fuel to -65°F in heat exchangers located in an alcohol bath. Carbon dioxide was blown into the alcohol bath and into the environmental box to maintain the ambient and fuel temperatures at -65°F. Figure 20 shows the environmental box at -65°F.

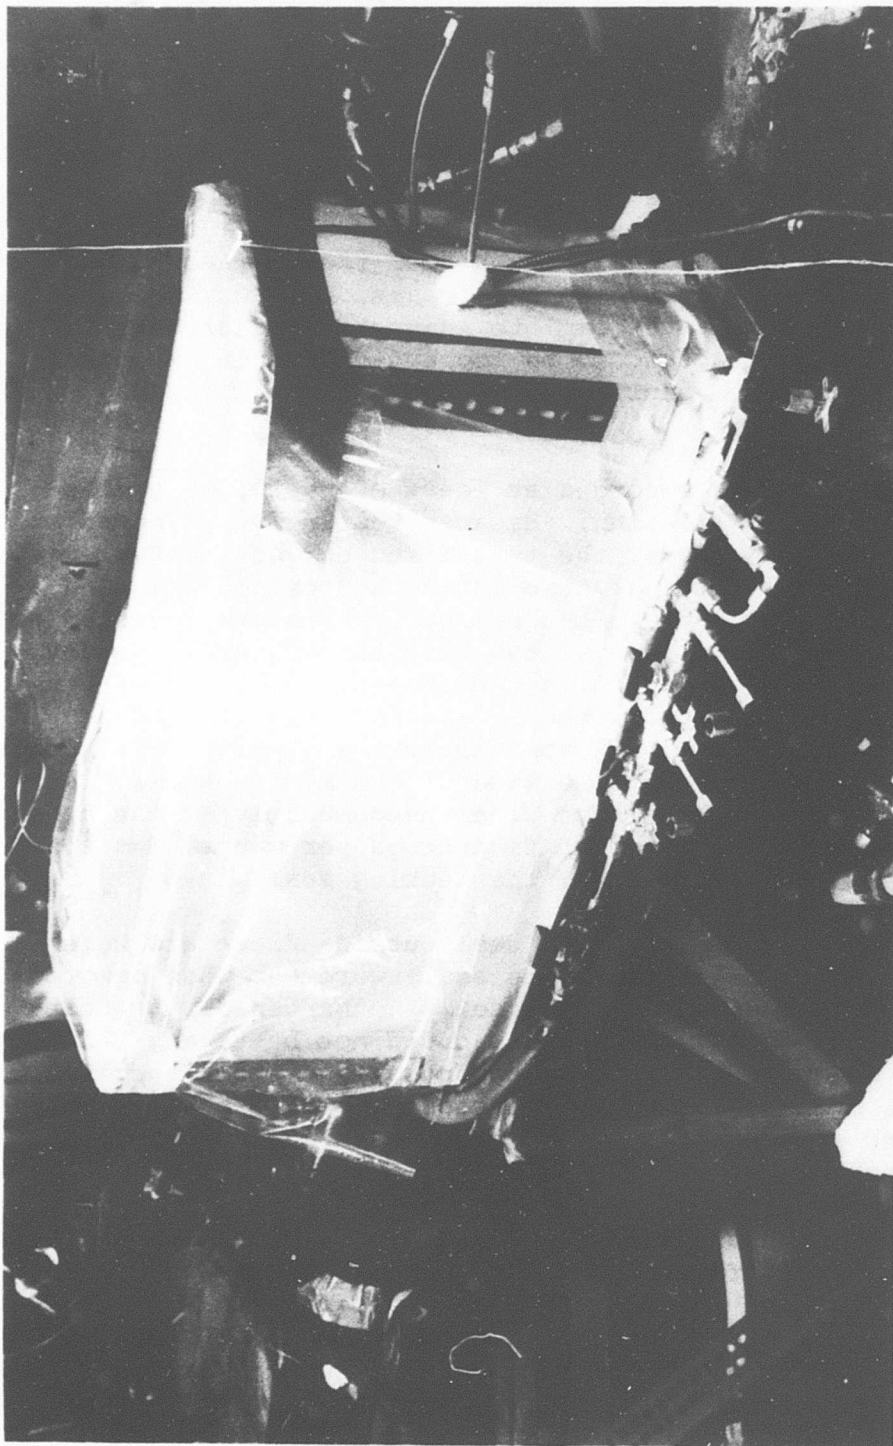
Figure 21. Seal Test Setup for Sand and Dust Environment Test.

Sand and dust environment testing was achieved by closing the environmental box hermetically after introducing enough sand and dust to maintain a minimum concentration of 1.5 \pm 0.4 gram of sand and dust per cubic foot of box volume. The mixture of air and sand and dust was kept in continuous motion by blowing air intermittently inside the box. Figure 21 shows the sand and dust test setup. The sand and dust mixture consisted of 90 percent silicon dioxide, was angular in structure and screened as follows:

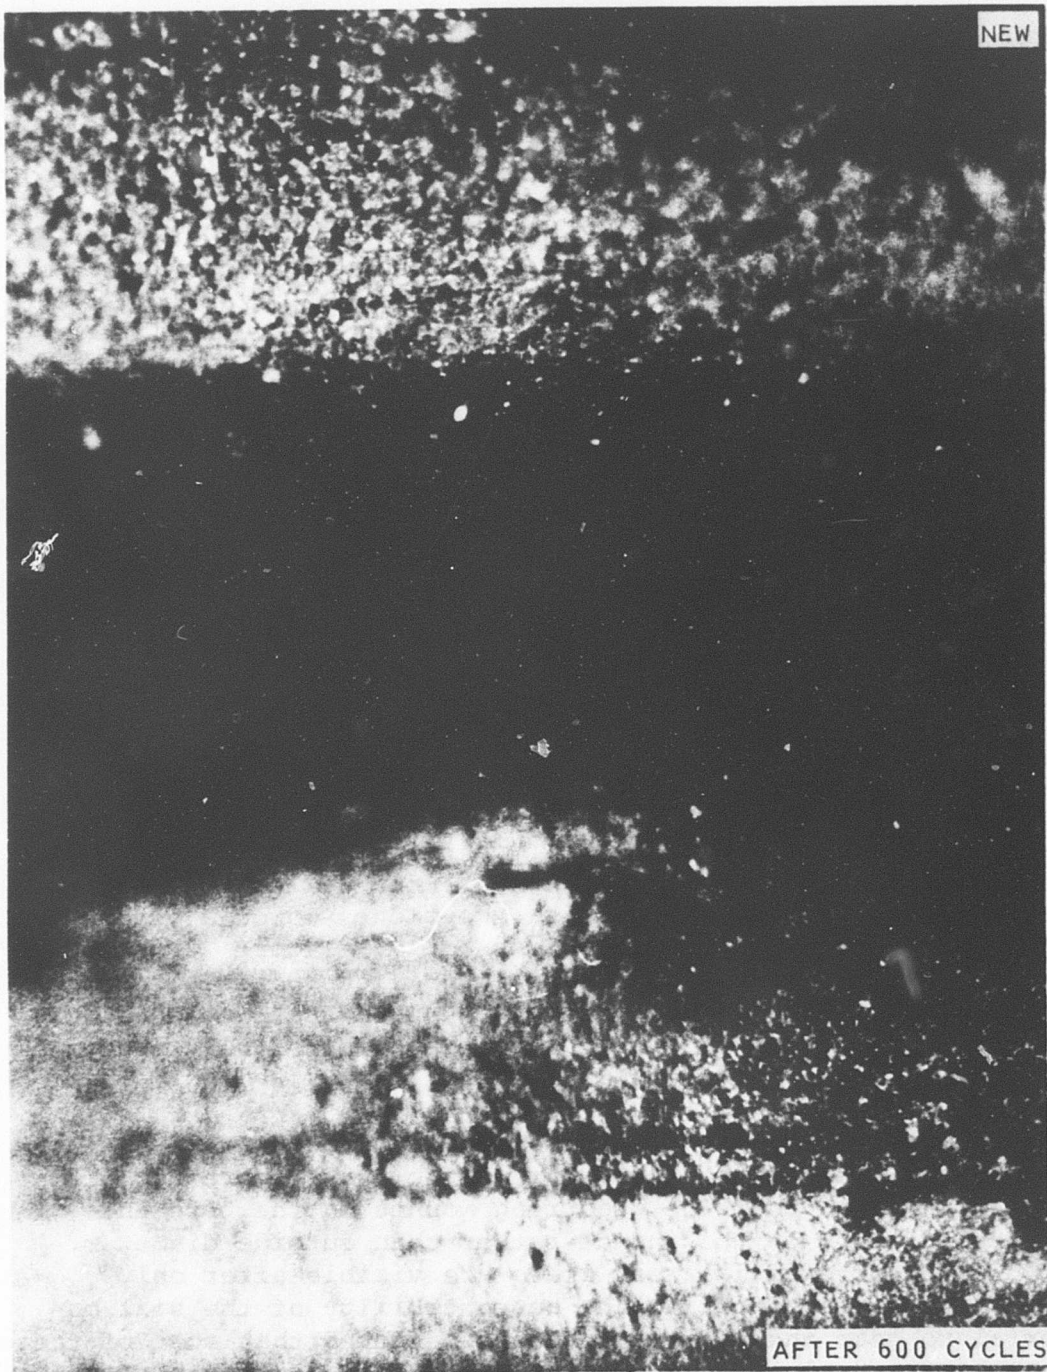
Figure 22. Rotary Seal Polyurethane A-1086.

The first seal listed in Table 10 is a polyurethane compound A-1086. All six seals of that type failed at hot test. Two of them lasted 30,000 cycles at -65°F but failed after only 600 cycles at 250°F. All seals except one showed a severe breakdown of the material at disassembly. Figure 22 shows a new and a used seal side-by-side, magnified 30 times. Although not revealed by the photo, the used seal was considerably flattened at the outer circumference after only 600 cycles, which is the reason it leaked.

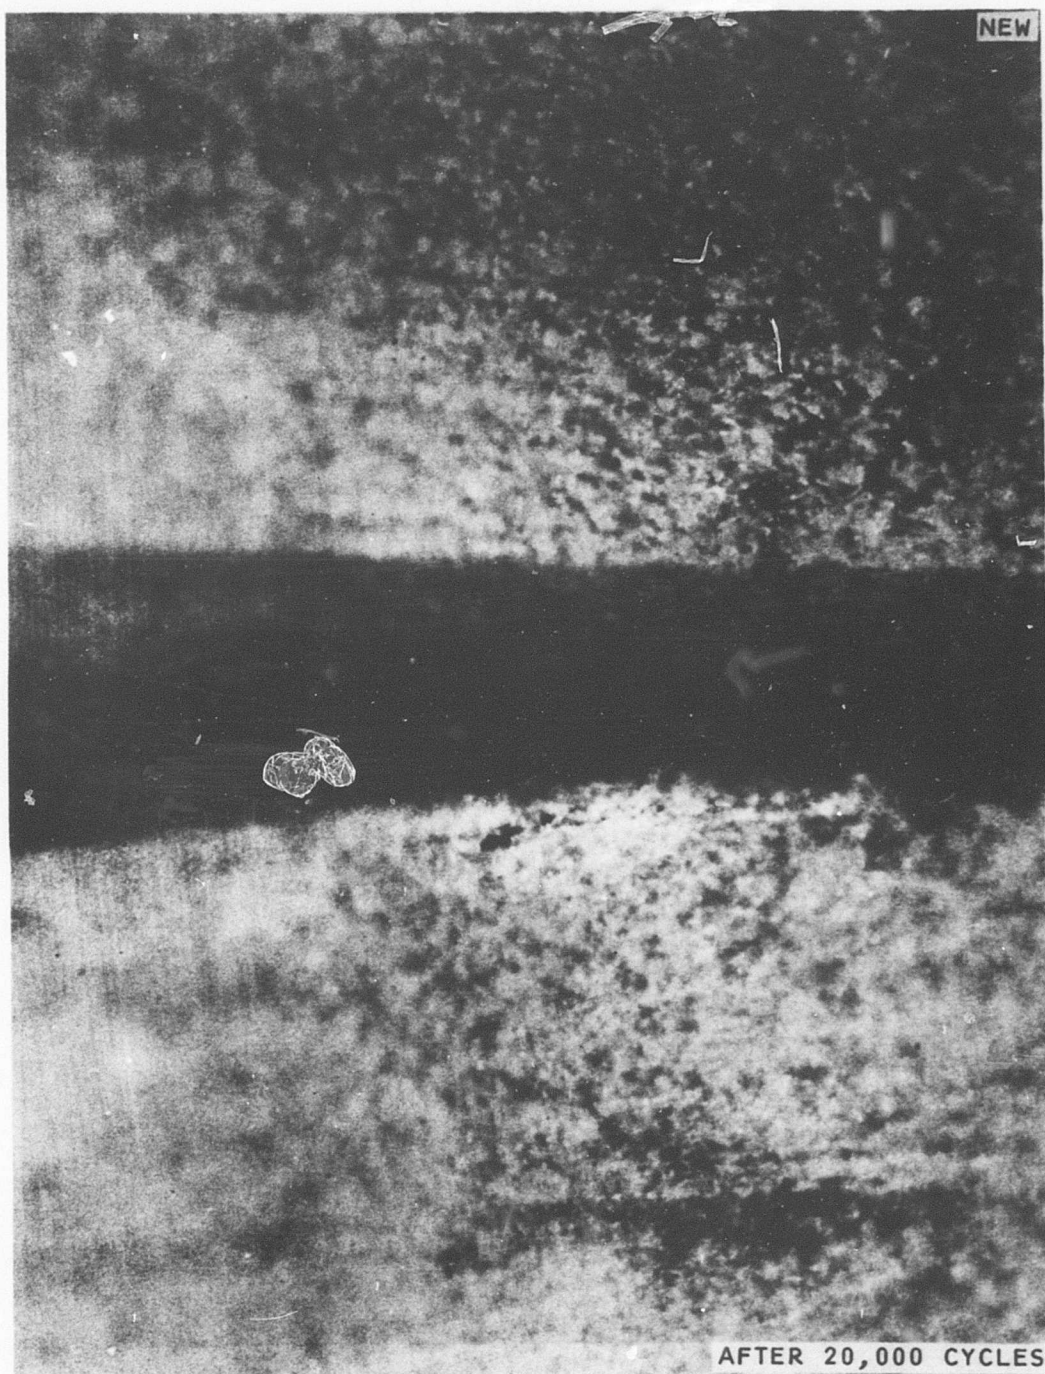
Figure 24. Rotary Seal Tetralon 720.

Four Tetralon 720 seals were run 20,000 cycles each. The first two were assembled with a smaller size O-ring than recommended by the manufacturer because of difficulties in assembling the seal on the test shaft. After leakage developed at cold test, the manufacturer suggested that a correct size O-ring be used as originally specified. The next two seals were assembled with the specified O-ring and failed after 20,000 cycles at 250°F. At disassembly, the fluorosilicone O-ring showed signs of being crushed, pointing to excessive squeeze. Unfortunately, because of the thin wall of the Tetralon ring, its hardness could not be measured. It is expected that the hardness would be much higher than that of rubber O-rings. Consequently, leakage becomes a function of the finish of the seal and that of the sleeve bore. Weight change for three seals was insignificant. The fourth seal lost 11.7 percent of its weight at the same time, increasing its width by 14.8 percent. This increase in width indicates an excessive squeeze caused by the O-ring which acts as a mechanical spring. The specific gravity tended to increase rather than decrease, pointing to the absorption characteristic of TFE. Diameters were not measured. Figure 24 shows a new seal next to a seal which ran for 20,000 cycles. The left side of the photo is out of focus, which is the reason for the blur. There is little evidence of wear; however, the surface of the used seal seemed to be somewhat smoother than that of the new one.

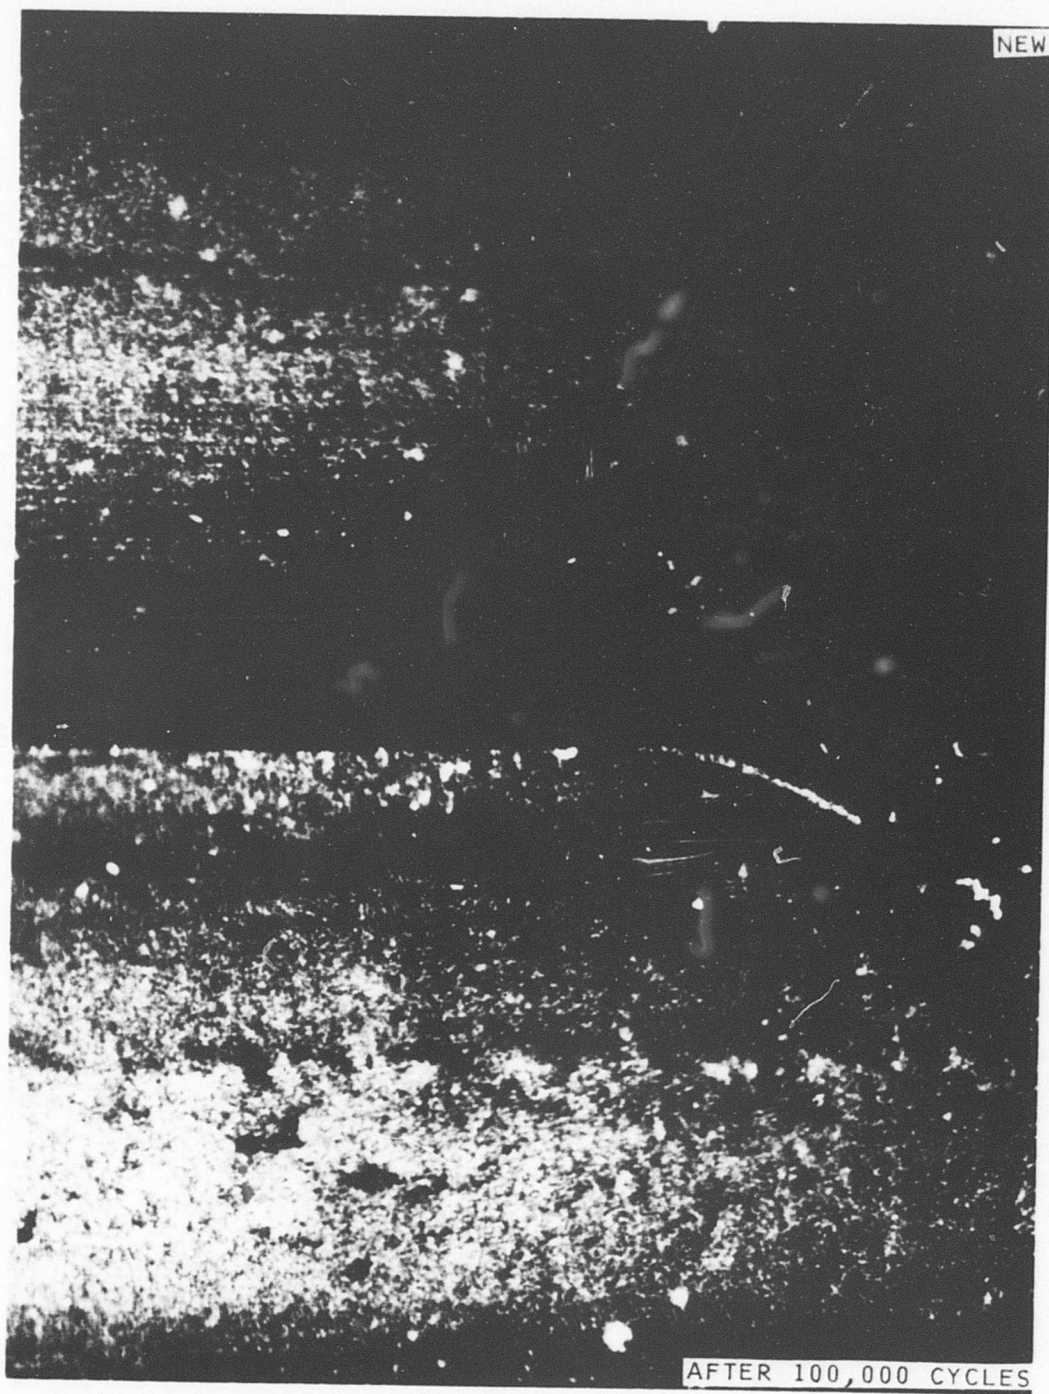
Figure 26. Rotary Seal Buna XN 1996-2.

Four out of seven Buna XN 1996-2 seals completed 100,000 cycles. The decrease in weight varied between 10 and 31 percent, indicating substantial wear not visible on the photograph, Figure 26. This wear was confirmed when measuring the change in thickness. Specific gravity varied ± 3 percent. This variation did not indicate a trend leading to a conclusion. Hardness increased up to 16.5 percent but the increase is not constant from one seal to another. Three of the seven seals were cut when removed from the test shaft groove, indicating a loss of tensile strength which, when coupled with the increase in hardness, could lead to cracks while in operation, and eventually to leakage. This Buna XN 1996-2 seal was treated with an ultralube process designed to reduce friction and ultimately reduce wear. There are no indications that this ultralube process accomplished the goal it was intended to do since weight loss was 10 to 31 percent. All seven seals of this type completed 89,000 cycles or better and yet the changes in mechanical characteristics of all seals are spread over a wide range, pointing to an unstable material requiring further refinement. Figure 26 shows a new seal next to one that completed 100,000 cycles without leakage. A slight cut is visible on the side of the test seal, on the right side of the photo. This sliver, 0.002-inch wide, was most likely cut when the test pressure forced the seal in the clearance between the test shaft and the sleeve. This clearance is, by design, 0.0005 to 0.0035 inch. In addition, the photo shows the used seal outside diameter to reflect the light better than the new one, due to a smoother surface resulting from wear.

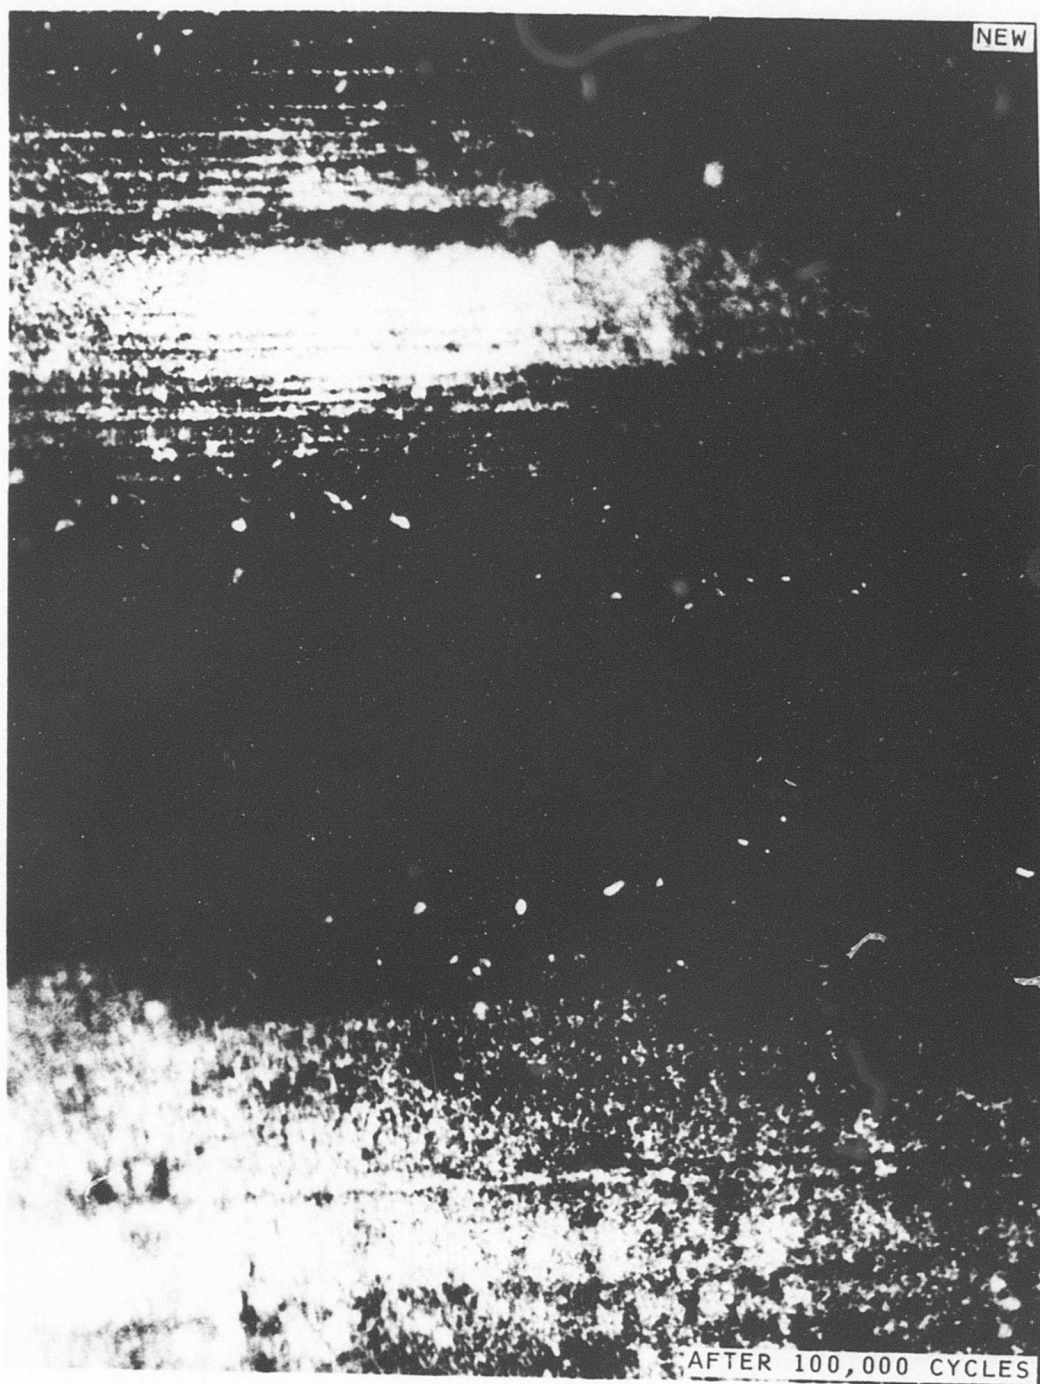
Figure 28. Rotary Seal Nitrile C-69.

The Nitrile C-69 seal is shown in Figure 28. The circumferential lines visible in the new seal are worn away in the 100,000 cycle seal; however, this wear is minimal because the mold flash of the tested seal is still visible. All six seals tested completed 100,000 cycles each without leaking. The changes in properties are not too different from the two Buna N seals; however, the changes are more consistent, indicating a more stable material, thus a better seal. This seal is qualified to MIL-P-5315. Table 14 lists the properties of the C-69 seal as well as the specified limits. Two properties stand out as being better in the C-69 seal: First, the tensile strength is highest of the group at 1740 psi. This explains why only one C-69 seal was cut at disassembly while being pulled out of its groove. Obviously, the higher the tensile strength of the seal, the better the protection of that seal will be against tearing and possibly pinching. Second, the compression set is the lowest of the group at 7 percent at 158°F for 70 hours. Note that 30,000 cycles at 250°F corresponds to 25 hours of testing.

The last seal listed in Table 11 was a nitrile compound C-69. This is the same type of seal as the rotary listed in Table 10, although a different size was used. In each case, all six samples completed 100,000 cycles without leakage. This seal was reviewed as a rotary seal. The analysis of the rotary type applies as well to the translational type. Comparing the changes in physical properties listed in Tables 10 and 11, it is obvious that these changes were consistent, indicating again a stable material. More significant is the fact that the majority of the samples tested experienced changes contained within a very narrow band, further confirming the consistent quality from one seal to another. Figure 36 shows two seals side-by-side; one new, the other after 100,000 cycles. Axial wear lines are visible on the tested seal. These wear lines are less than 0.0005 inch wide and do not appear to be very deep. The mold flashes are visible in both seals, indicating little wear in the tested seal. There is no evidence of flatness or deformation.

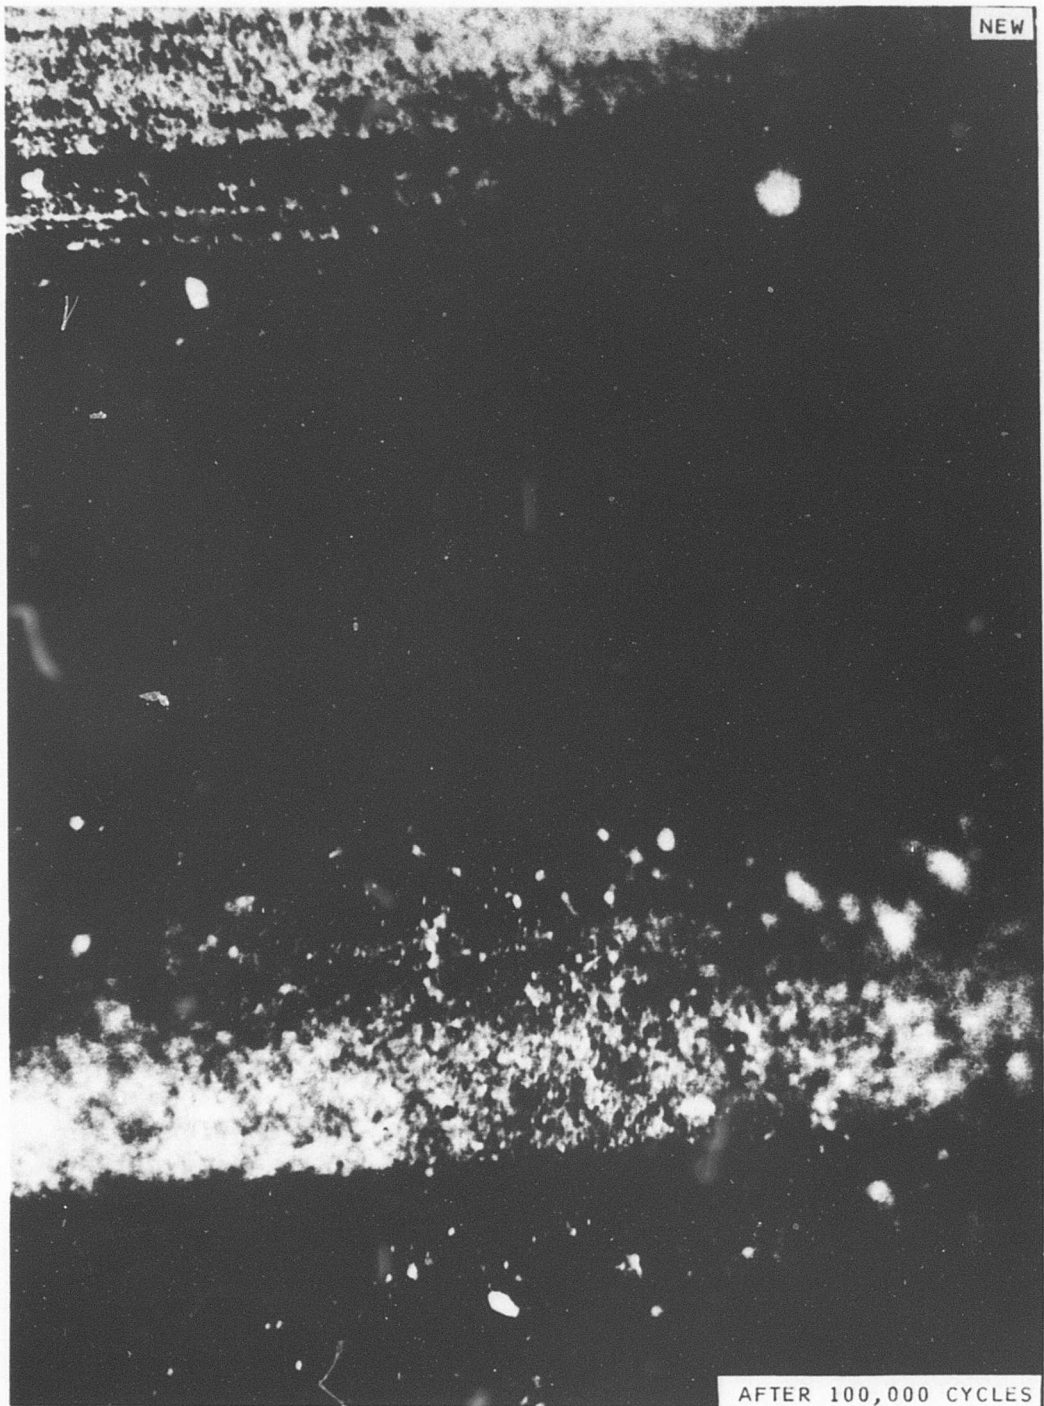
Figure 30. Rotary Seal Buna N 9021 in TFE-Coated Groove.

The second Buna N 9021 configuration is an O-ring assembled in a TFE-coated groove. Four out of six samples completed 100,000 cycles. One failed after 74,000 cycles and was so badly damaged before disassembly that no measurements were possible. Another failed after 36,000 cycles with a weight loss of 5.9 percent. The other four samples experienced weight losses of 14.4 to 20.6 percent, and one lost 7.3 percent of its thickness while the other three retained their thickness. The significant fact is that none of the samples examined increased its hardness and at the same time none increased its specific gravity by more than 5 percent. It can be theorized that the groove TFE coating transferred from the groove to the O-ring, thereby preventing the loss of lighter components as in other cases. The tested seal shown in Figure 30 exhibits the same darker area as the one shown in Figure 29. The object of a

TFE-coated groove was to eliminate rubbing between the O-ring and the sleeve bore and to have rubbing occur instead between the O-ring and the shaft groove. However, this resulted in additional wear, although it is not clearly shown in the photo.

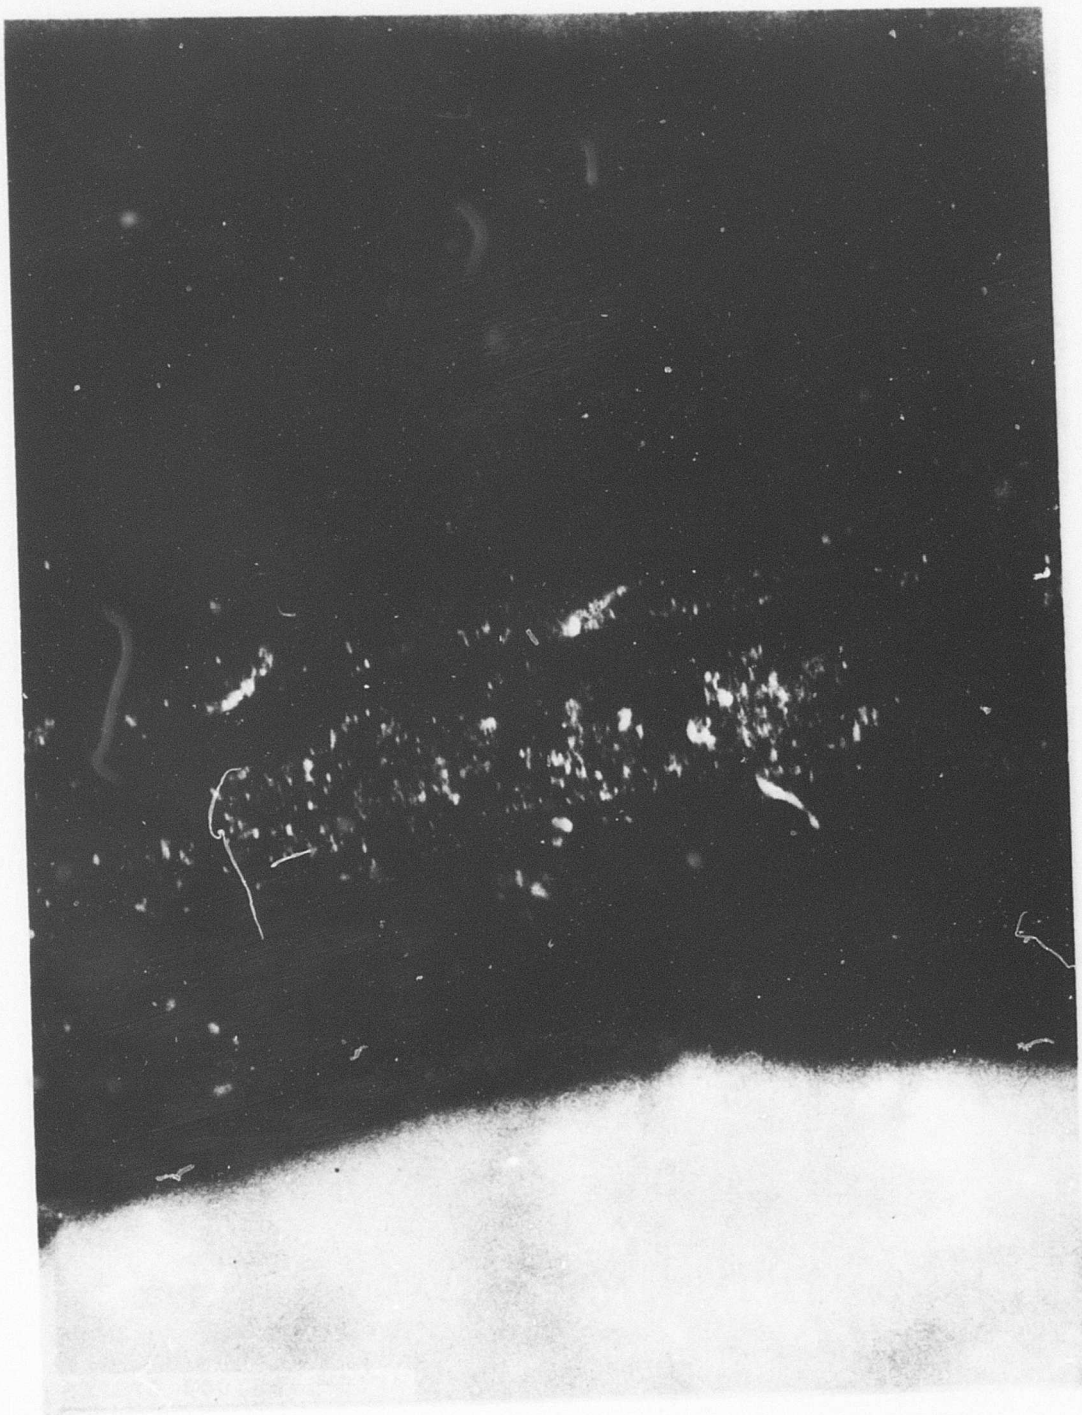
Figure 31. Rotary Seal Buna N 9021 With Backup Ring.

The third Buna N 9021 configuration consists of an O-ring assembled with a TFE backup ring. Two samples completed 100,000 cycles, two failed after 32,000 cycles, and two failed after 20,000 cycles. Weight loss ranges from 4 to 11.7 percent, and is lower than that of the two previous Buna N 9021 configurations. The increase in specific gravity and in hardness is similar to that of the Buna N O-ring used without TFE coating. The change in thickness is insignificant. Test results indicate that the TFE backup ring did not help in any way the performance of the O-ring. Figure 31 shows the side of a tested O-ring. Minute flakes of material were gouged from the O-ring, and were found stuck to other sections of the O-ring. It should be noted that the backup ring is split at an angle of 22° to permit assembly in the groove. If this split is responsible for removing the particles from the O-ring, relative motion between the O-ring and the split ring had to take place.

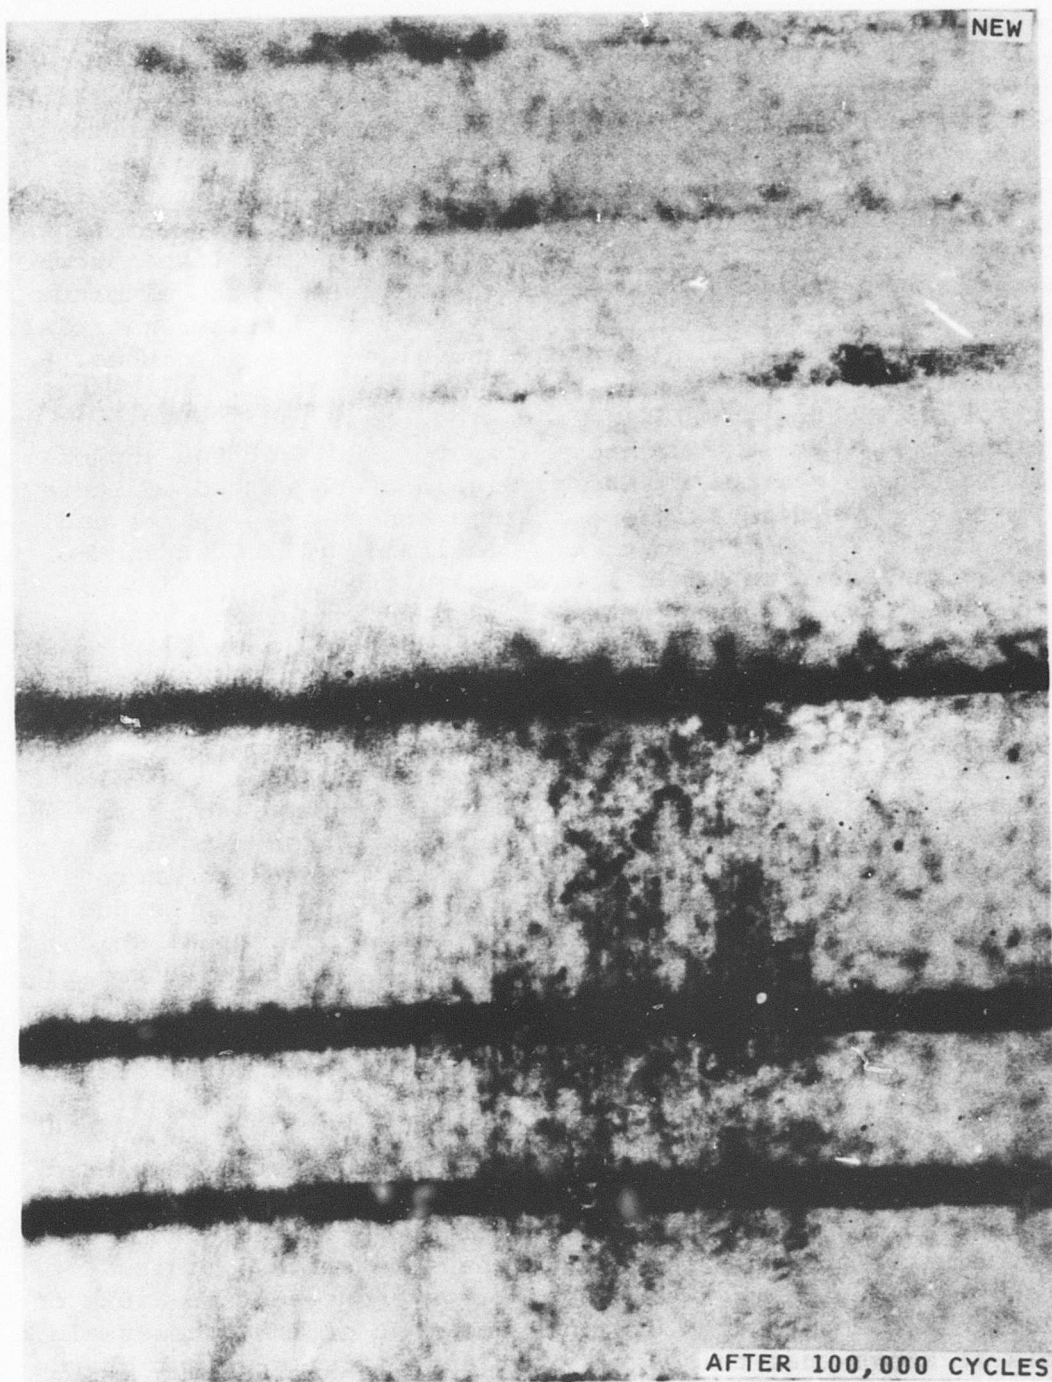
Figure 33. Translational Seal Tetralon 720.

The Tetralon 720 seals are of the same material as the rotary seal listed in Table 10 but of a different configuration. Only one of the six seals completed 100,000 cycles and then a slight leakage occurred toward the end of testing (one drop/minute). Hardness and diameters could not be measured. The only significant physical change is the increase in thickness due to the flowing characteristic of that material. Axial wear lines are shown in Figure 33. The dark circumferential lines shown on the tested seal are grooves which are filled with aluminum oxide. As in the case of the rotary seal of the same material, leakage is a function of the seal and sleeve bore finishes.

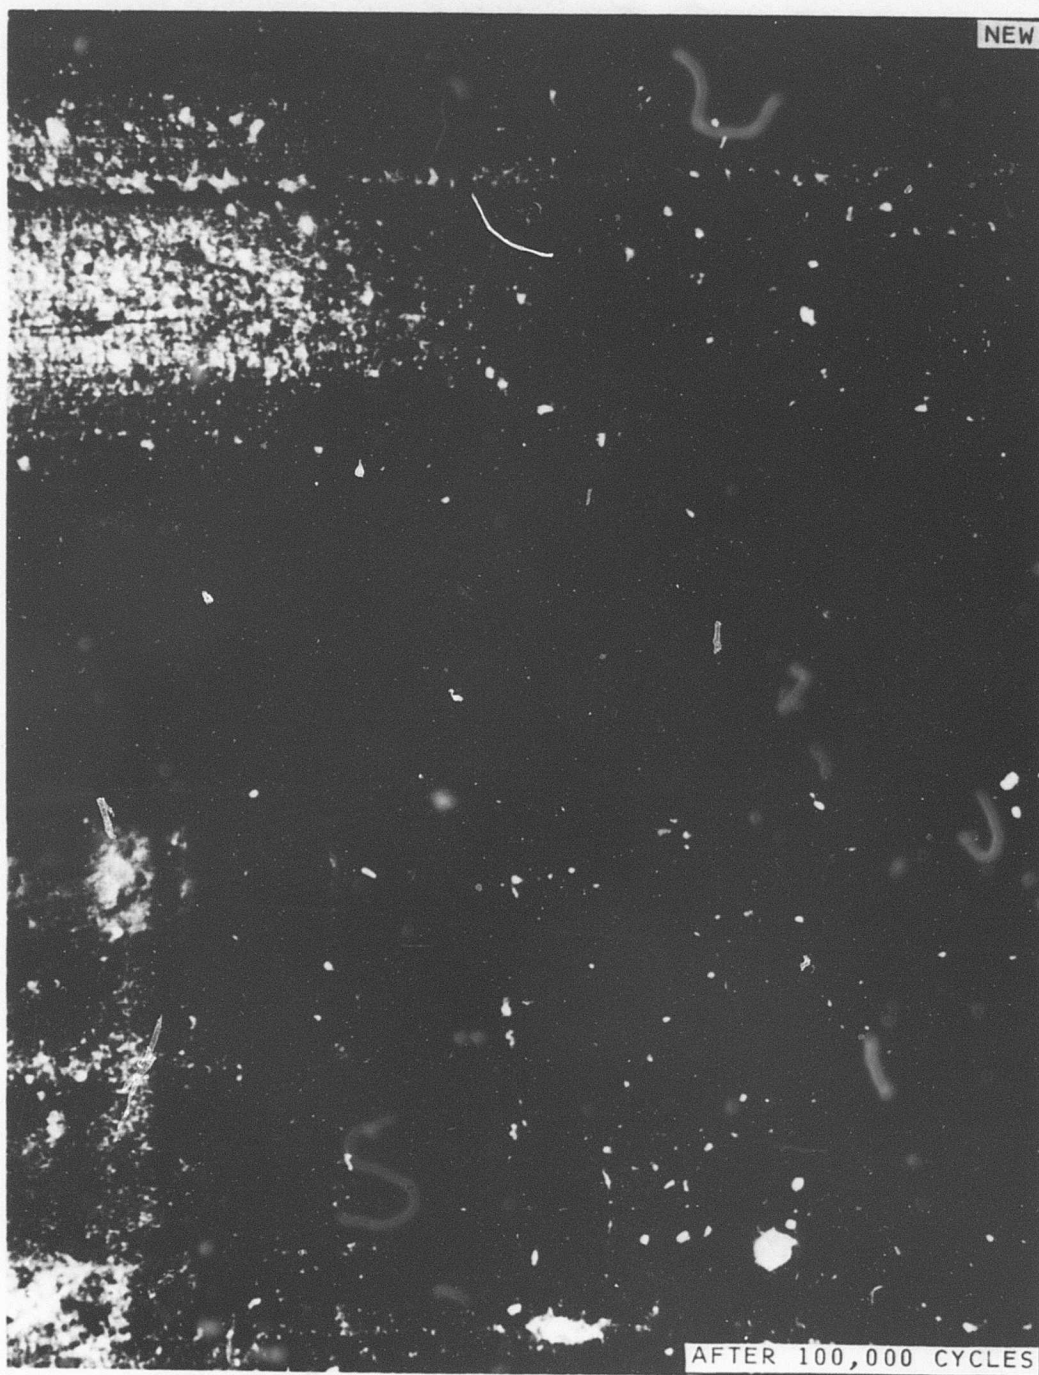
Figure 34. Translational Seal Buna N 756-75.

Four of six Buna N 756-75 seals tested completed 100,000 cycles; two of these four had a slight leakage at the end of testing (2 and 4 drops/minute). Figure 34 shows two of these seals side-by-side. Axial wear lines are visible on the seal which completed 100,000 cycles. Confirming this wear is the weight loss shown in Table 11. It should be noted that, although the tested seal shown in Figure 34 appears to have flattened out, none of the seals tested took a compression set. This seal was treated with an ultralube process designed to reduce friction and wear. As in the case of the rotary seal Buna XN 1996-2, this process failed to reduce the wear. Hardness increased as a function of the number of cycles completed to a maximum of 18.5 percent. Specific gravity also increased up to 5.8 percent and physical measurements tended to decrease, indicating shrinkage of the seals. Hardness increase is related to the increase in specific gravity which is due to compression set. This loss leads to a denser material which is harder to compress. It is interesting to note that rotary seals of the same material were fairly successful and did not show any wear, as can be seen in Figure 27. This leads to the conclusion that rolling motion of the seal tends to accelerate wear.
